Case Report

A Rare, Late Complication after Automated Implantable Cardioverter-Defibrillator Placement

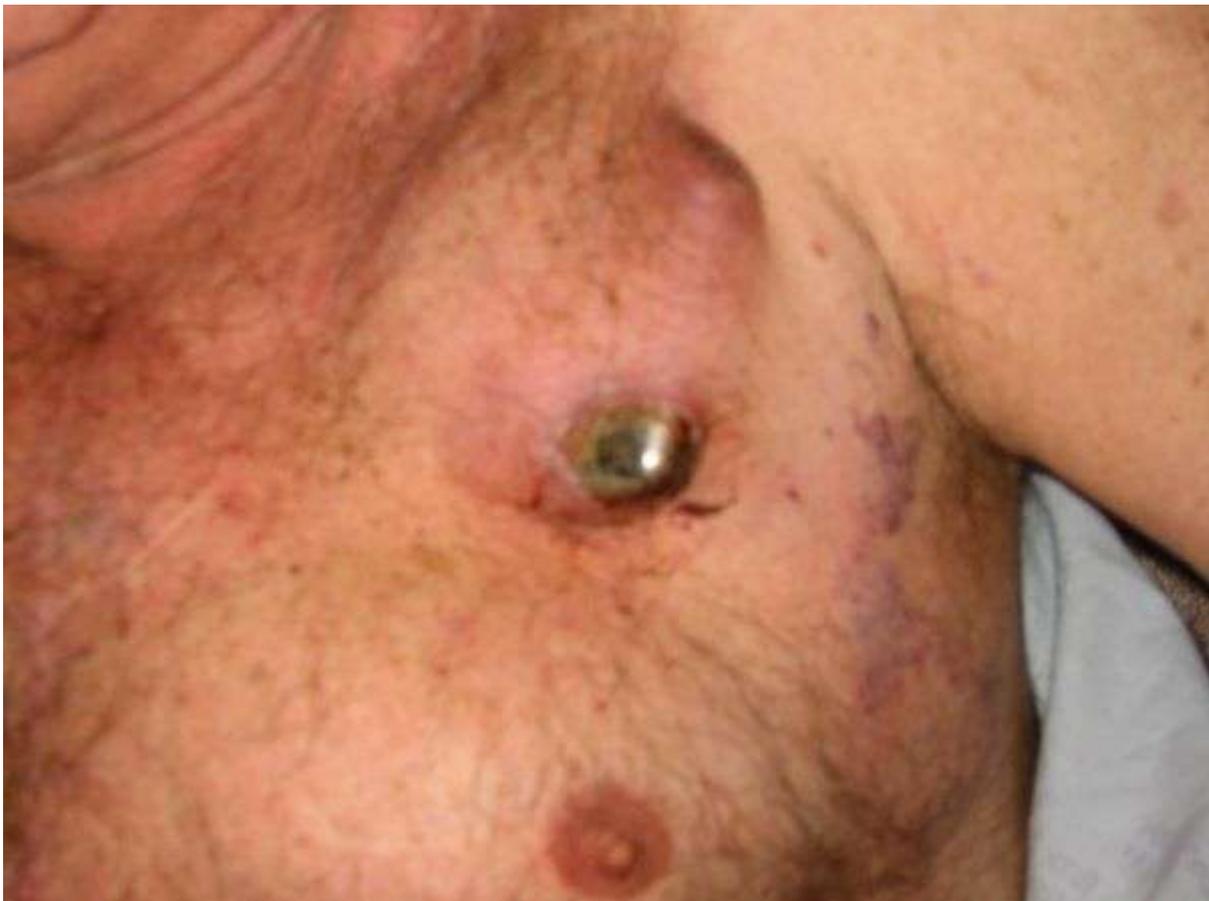
Figure 1. Photo of the patient depicting the erosion of the AICD through the skin.

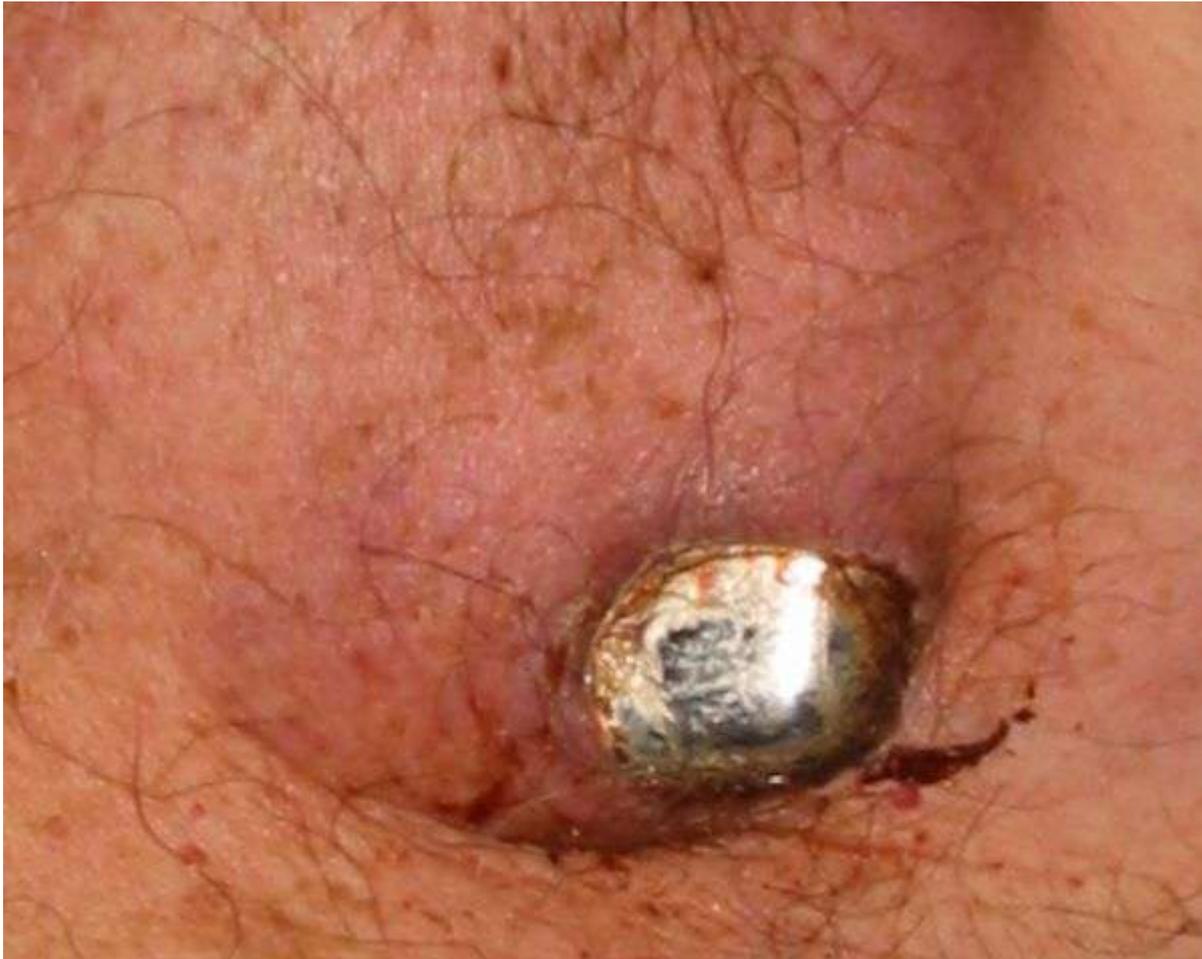
Figure 2. Close up examination of AICD of same patient eroding through the skin. Note upper right corner of subcutaneous pocket shows severe erythema with signs of pre-erosion.

The other cause of skin erosion is pressure necrosis of the overlying tissue and skin.³ Gross pacemaker extrusion is usually signaled by a preceding period of “pre-erosion,” during which there is discomfort and discoloration of thinning tissue tensely stretched over a protrusion

of the pacing apparatus (**Fig. 2**). Griffith et al. concluded that if pacemaker erosion is not caused by infection it can be successfully managed by ipsilateral re-implantation, a financially advantageous solution.⁵ Identification of pre-erosion allows salvage of the pacing system, as the hardware can be repositioned under the pectoralis muscle or in an abdominal location.
